Residential Damp, Timber & Mould Inspection Report

Example Property Address

25 March 2026

Report Ref: 8238420B

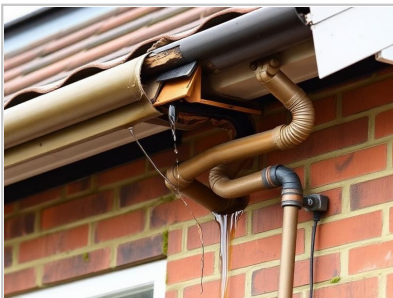
Photo 1 — Gutters & Downpipes

Rear elevation gutter at first floor level is leaking at joint. Evidence of long-term water discharge onto brickwork below causing algae growth and staining. Downpipe connection appears corroded and requires replacement.

Leaking gutter joint at rear first floor level with algae staining

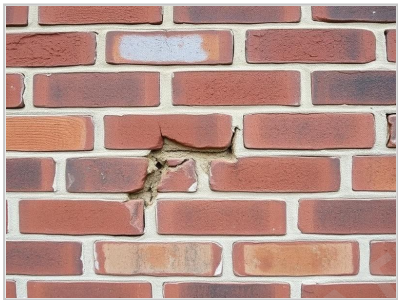
Significant deterioration of pointing to front elevation, particularly around bay window and at first floor level. Mortar joints are recessed by 15-20mm in places with visible erosion. Recommend full repointing to exposed

elevations to prevent water ingress.

Photo 1 — Pointing & Mortar Joints  
Deteriorated pointing to front elevation with recessed mortar joints  
Photograph taken at time of inspection.  
Photographs taken at time of inspection.

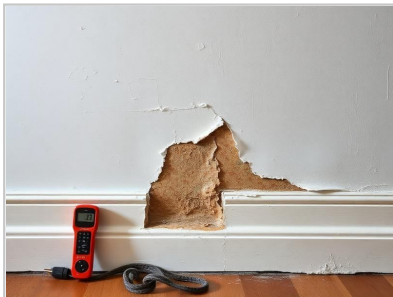
Rising damp identified to lower sections of external walls. Visible tide mark extending to approximately 750mm above floor level. Plaster is blown and friable below DPC height. Salt deposits (efflorescence) visible on wall surface. Skirting boards show early signs of decay.

Moisture reading: 26%

Photo 1 — Rear Reception Room  
Rising damp tide mark with salt deposits on rear reception wall

Immediate focus should be placed on the overall moisture environment, ventilation, and associated building defects before invasive damp-proofing works are specified. Hack off contaminated plaster to 300mm above tide mark and apply renovating plaster system. Allow to dry (minimum 6 months) before redecoration.

Replace affected skirting boards.

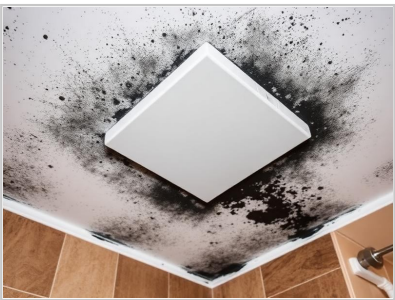
Black mould growth to ceiling around extractor fan and to external wall behind WC. Mould colonies measure approximately 0.8m<sup>2</sup> in total coverage. Ceiling paint is peeling. Extractor fan tested and found to be functioning but undersized for room volume. No background ventilation present (trickle vents painted over).

Condensation associated with elevated internal humidity and limited ventilation

Moisture reading: 20%

Photo 1 — First Floor Bathroom  
Black mould growth on bathroom ceiling around  
extractor fan

Treat all mould with specialist fungicidal wash and allow 48 hours drying time. Apply mould-resistant primer before repainting with anti-mould emulsion. Replace extractor fan with higher capacity unit (minimum 15 l/s for bathroom). Restore trickle vents to operational condition.

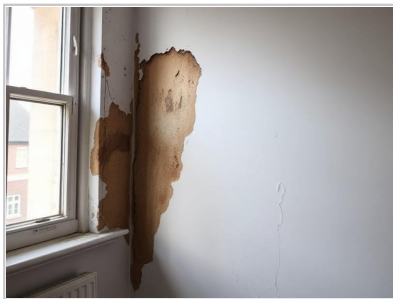
Photo 1 — Front Bedroom

Penetrating damp to external wall adjacent to window. Water staining visible extending from window reveal down to skirting level. Plaster is damp and soft when probed. Decorative finishes have failed with obvious water tracking marks. Issue appears to be related to defective window seals and deteriorated pointing to external brickwork.

Moisture reading: 22%

Penetrating damp and water tracking from window reveal in front bedroom

Renew external mastic seals to window frame. Repoint surrounding brickwork with appropriate lime mortar. Allow wall to dry naturally over 3-6 month period before replastering. Install trickle vents if not present.

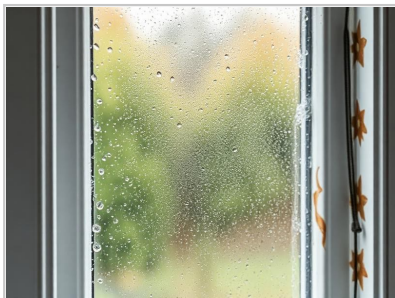
Photo 1 — Kitchen

Heavy condensation observed on windows with water streaming down glass and pooling on sills. Window frames showing early signs of mould growth at corners. Extractor hood above cooker vents internally (not to external). No mechanical extraction present.

Moisture reading: 16%

Heavy condensation streaming on kitchen window with mould on frames

Install mechanical extract ventilation to kitchen (minimum 30 l/s adjacent to hob, 60 l/s if remote). Redirect cooker hood to extract externally through wall or window. Treat window frames with fungicidal wash and Visible mould contamination may be removed through appropriate cleaning methods. However, cleaning alone should be considered a temporary measure only. Unless the underlying moisture conditions are addressed, mould growth is likely to return.
