Residential Damp, Timber & Mould Inspection Report

Example Property Address

23 March 2026

Report Ref: FE779854

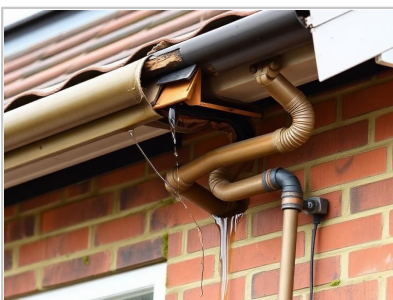
Photo 1 — Gutters & Downpipes

Rear elevation gutter at first floor level is leaking at joint. Evidence of long-term water discharge onto brickwork below causing algae growth and staining. Downpipe connection appears corroded and requires replacement. This is likely contributing to penetrating damp in rear bedroom.

Leaking gutter joint at rear first floor level with algae staining on brickwork below

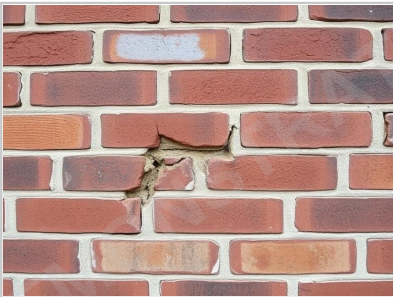
Significant deterioration of pointing to front elevation, particularly around bay window and at first floor level. Mortar joints are recessed by 15-20mm in places with visible erosion. Recommend full repointing to exposed elevations to prevent water ingress.

Photo 1 — Pointing & Mortar Joints  
Deteriorated pointing to front elevation with recessed mortar joints  
Photograph taken at time of inspection.  
Photographs taken at time of inspection.

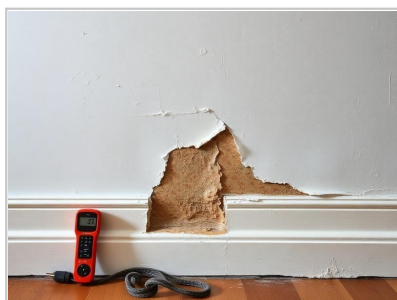
Photo 1 — Rear Reception Room

Moisture patterns observed at low level are consistent with possible rising damp; however, findings should be considered alongside the overall moisture assessment and may require further investigation to confirm causation to lower sections of all external walls. Visible tide mark extending to approximately 900mm above floor level. Plaster is blown and friable below DPC height. Salt deposits (efflorescence) visible on wall surface. Skirting boards are decayed and require replacement. Decorative finishes have failed with wallpaper peeling and emulsion flaking.

Rising damp at this severity is consistent with conditions that may constitute a Category 1 hazard under HHSRS. The presence of salt contamination and failed finishes creates an environment conducive to mould growth. Prompt investigation and timely progression of remedial works is recommended, particularly where vulnerable occupants may be affected.

Rising damp tide mark and salt deposits on rear reception room wall

Immediate focus should be placed on the overall moisture environment, ventilation, and associated building defects before invasive damp-proofing works are specified. Hack off contaminated plaster to 300mm above tide mark and apply renovating plaster system. Allow to dry (minimum 6 months) before redecoration. Replace all affected skirting boards. Consider installation of positive input ventilation to assist drying.

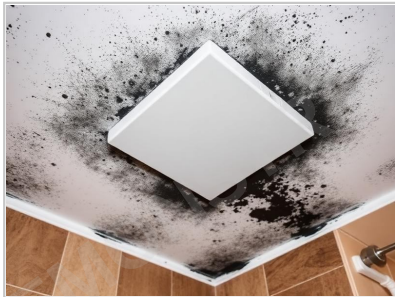
Photo 1 — First Floor Bathroom

Extensive black mould growth to ceiling around extractor fan and to external wall behind WC. Mould colonies measure approximately 1.5m<sup>2</sup> in total coverage. Ceiling paint is peeling and substrate is damp to touch. Extractor fan tested and found to be functioning but undersized for room volume. No background ventilation present (trickle vents painted over).

Condensation associated with elevated internal humidity and limited ventilation

This level of mould growth represents a serious respiratory health hazard, particularly for vulnerable occupants including children and those with asthma. Urgent assessment and remedial action is recommended to mitigate the health risk. Interim safety measures should include enhanced cleaning and provision of dehumidifier pending permanent remediation.

Extensive black mould growth on bathroom ceiling around extractor fan

Treat all mould with specialist fungicidal wash and allow 48 hours drying time. Apply mould-resistant primer before repainting with anti-mould emulsion. Replace extractor fan with higher capacity unit (minimum 15 l/s for bathroom). Restore trickle vents to operational condition. Consider installation of humidistat to automate extraction. Occupants to be advised on ventilation practices.

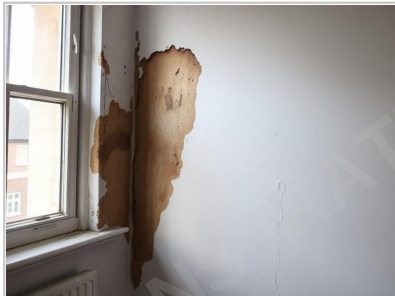
Photo 1 — Front Bedroom 1

Penetrating damp to external wall adjacent to window. Water staining visible extending from window reveal down to skirting level. Plaster is damp and soft when probed. Decorative finishes have failed with obvious water tracking marks. Issue appears to be related to defective window seals and deteriorated pointing to external brickwork.

Penetrating damp affecting bedroom creates conditions conducive to mould growth and impacts thermal comfort. Findings are consistent with a Category 1 hazard. Prompt investigation and timely progression of remedial works is recommended to address the source of moisture ingress.

Penetrating damp and water tracking marks adjacent to front bedroom window

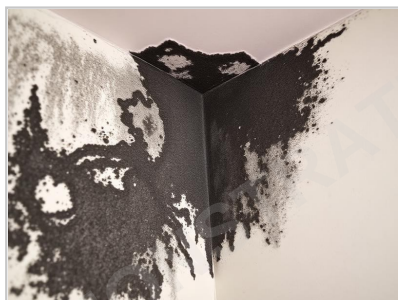
Mould growth should generally be considered a symptom of elevated moisture conditions rather than the primary defect.

Severe recurring mould at this level presents significant health risks including respiratory conditions, allergic reactions, and infections. Findings are consistent with a Category 1 hazard requiring urgent assessment. Consideration should be given to interim safety measures for vulnerable occupants pending remediation. Urgent remedial action is advised.

Photo 1 — Rear Bedroom 2  
Severe recurring black mould at corner junction  
of external walls in rear bedroom

Professional mould remediation required given extent and recurrence. Install mechanical extract ventilation with humidistat control. Improve heating provision - consider radiator upgrade or secondary heat source. Apply thermal lining to cold external walls after remediation. Advise occupant on furniture positioning and ventilation practices. Consider whole-house positive input ventilation system.

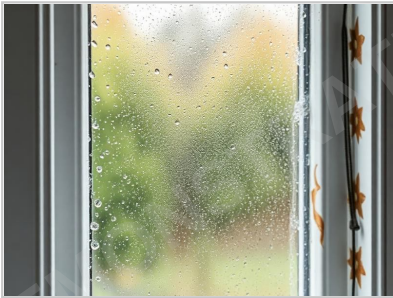
Heavy condensation observed on windows with water streaming down glass and pooling on sills. Window frames showing early signs of mould growth at corners. Extractor hood above cooker vents internally (not to external). No mechanical extraction present. Tumble dryer venting internally adding to moisture load.

Photo 1 — Kitchen/Diner  
Heavy condensation streaming on kitchen window with early mould on frames

Install mechanical extract ventilation to kitchen (minimum 30 l/s adjacent to hob, 60 l/s if remote). Redirect cooker hood to extract externally through wall or window. Redirect tumble dryer vent to external or replace with condenser unit. Treat window frames with fungicidal wash and Visible mould contamination may be removed through appropriate cleaning methods. However, cleaning alone should be considered a temporary measure only. Unless the underlying moisture conditions are addressed, mould growth is likely to return. Consider installation of condensation control unit or PIV system.
